**TRANSMITTAL
ASSESSMENT OF DAM SAFETY OF
COAL COMBUSTION SURFACE IMPOUNDMENTS
DRAFT INSPECTION REPORT
SITE 30 (BRUCE MANSFIELD)**

DAM SAFETY INSPECTION NOTICE

DEP Office	SWRO- PITTSBURGH	Phone	4124424000	Dam Permit or ID. #	D04-049
Address	400 WATERFRONT DR BH PA 15222			Dam or Project Name	LITTLE BLUE RUN
Owner or Permittee	FIRST ENERGY GENERATION CORPORATION			County	BEAVER
Complete Mailing Address	BRUCE MANFIELD PLANT PO Box 128 SHIPPINGPORT PA 15077-0128			Municipality	GREENE TOWNSHIP
				Take GPS readings at the center of the crest of the dam.	
				Latitude:	40° 37' 40.14" N
				Longitude:	80° 30' 47.79" W

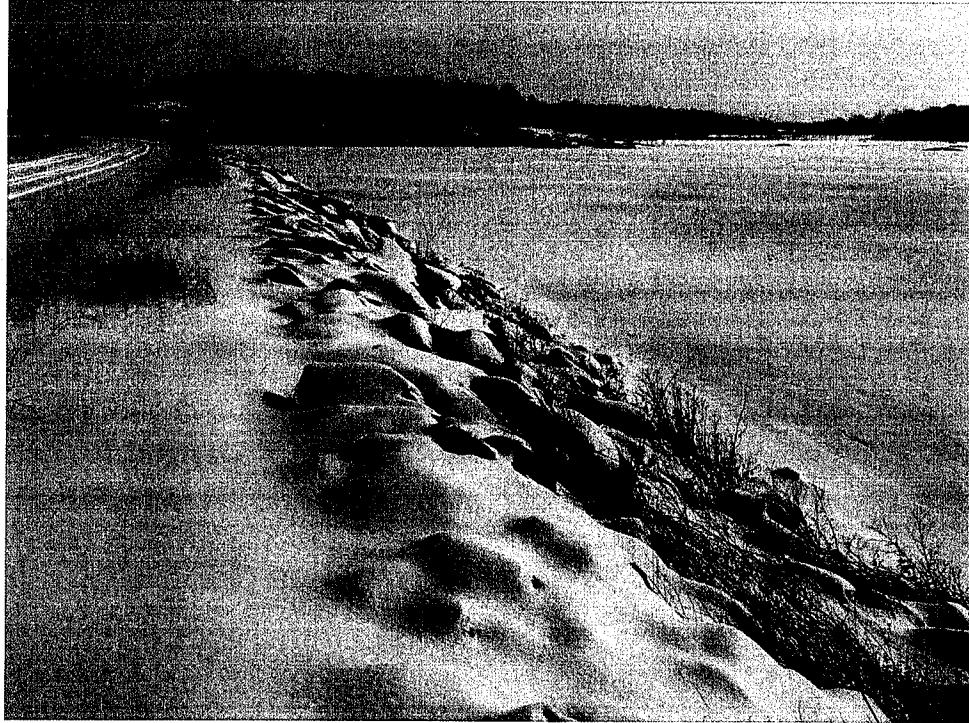
D04-049 01/21/09 Figure 4 View of primary spillway inlet and treatment system.

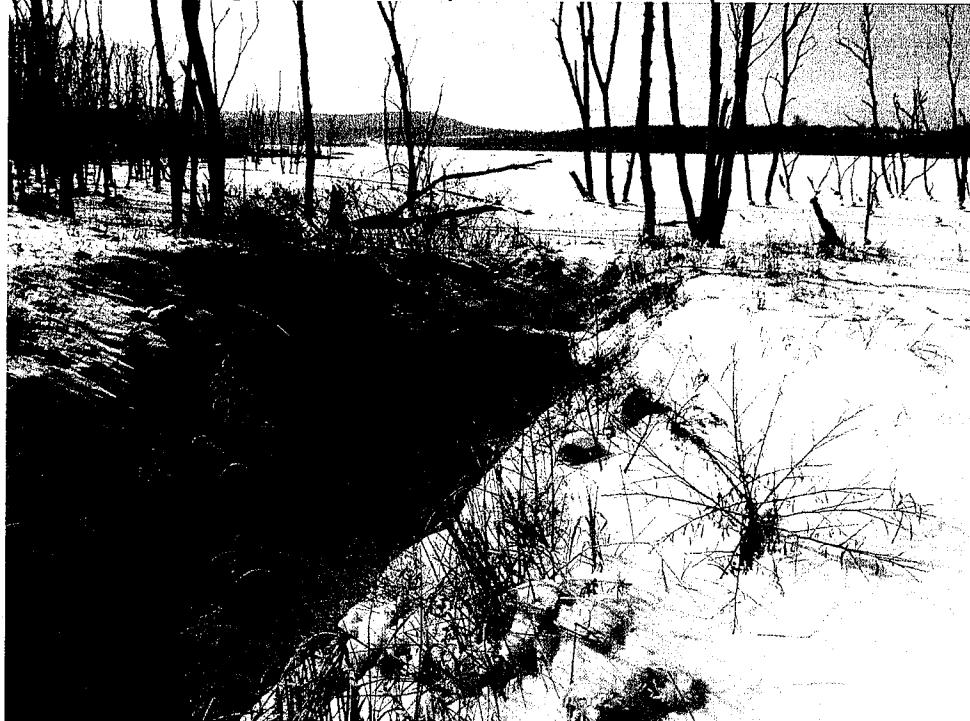
D04-049 01/21/09 Figure 6 View of discharge of primary spillway pipe.

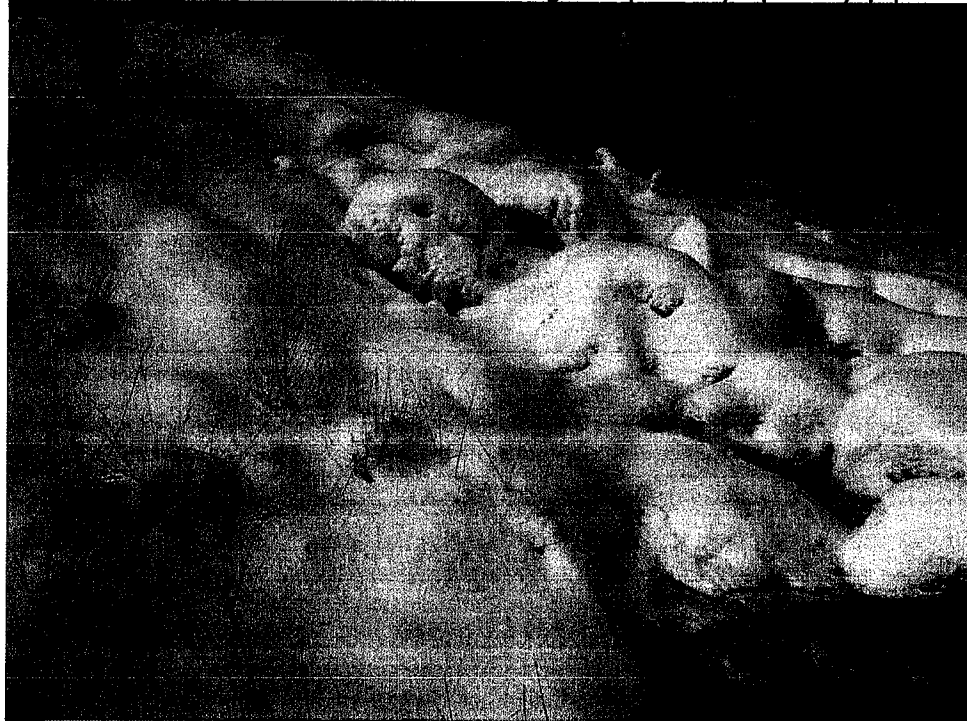
D04-049 01/21/09 Figure 7 View of gabion lined ditch below primary spillway discharge.

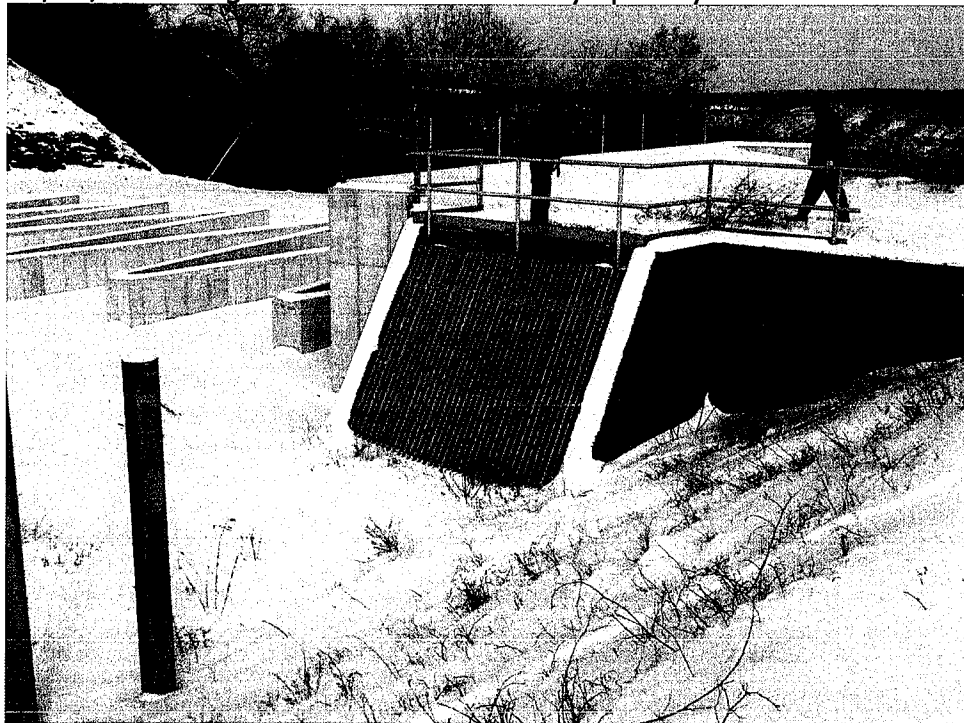
D04-049 01/21/09 Figure 9 View of secondary spillway discharge at stilling basin.

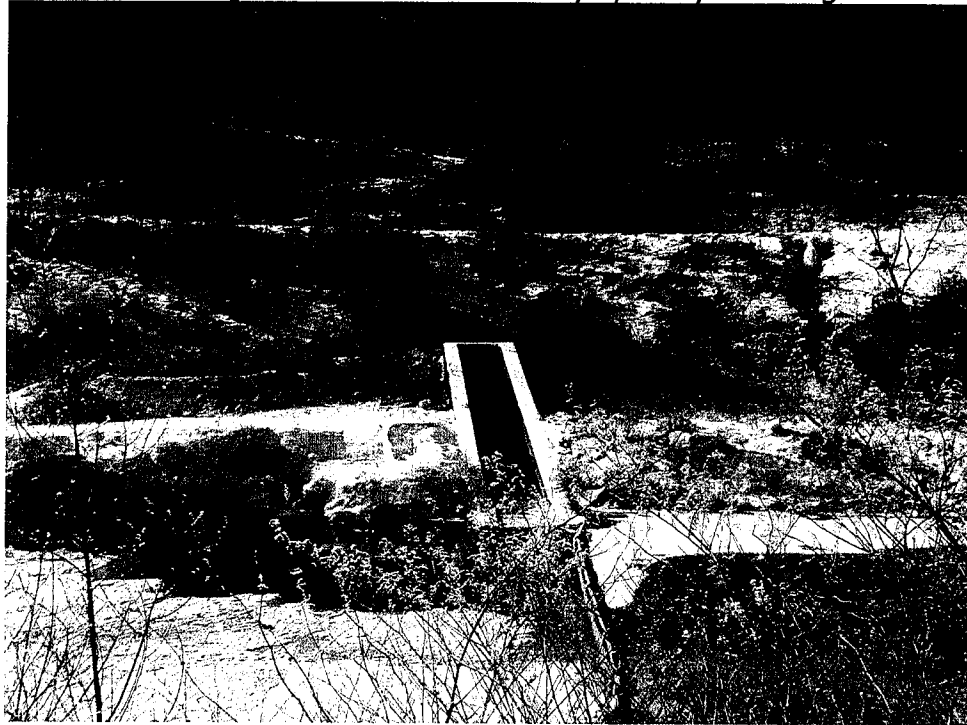
D04-049 01/21/09 Figure 10 View of emergency spillway entrance and labyrinth.

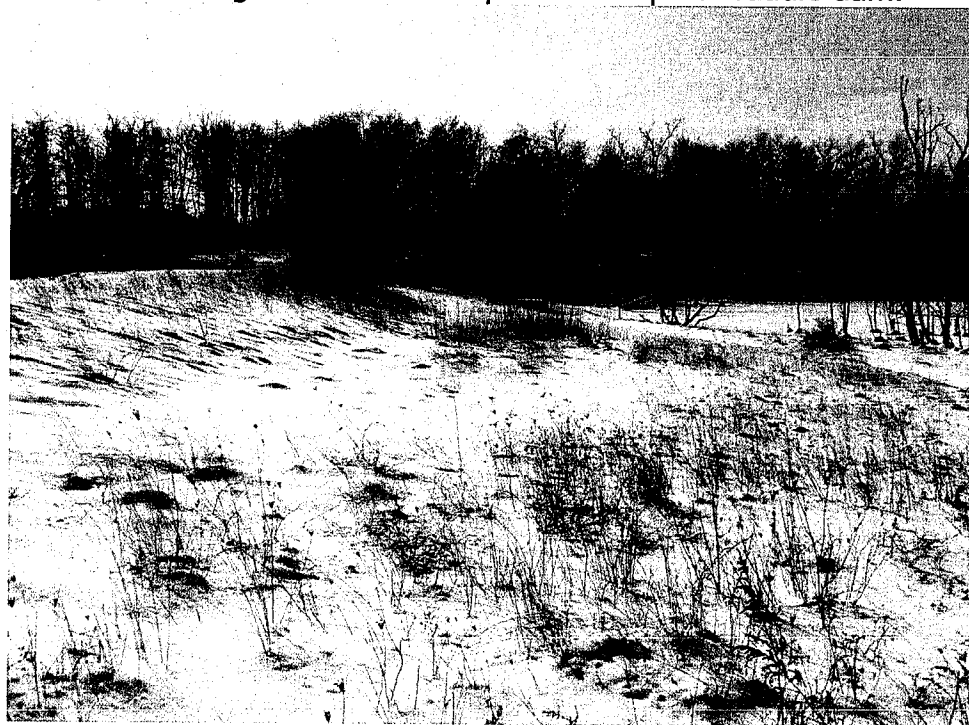
D04-049 01/21/09 Figure 21 View of geotube.

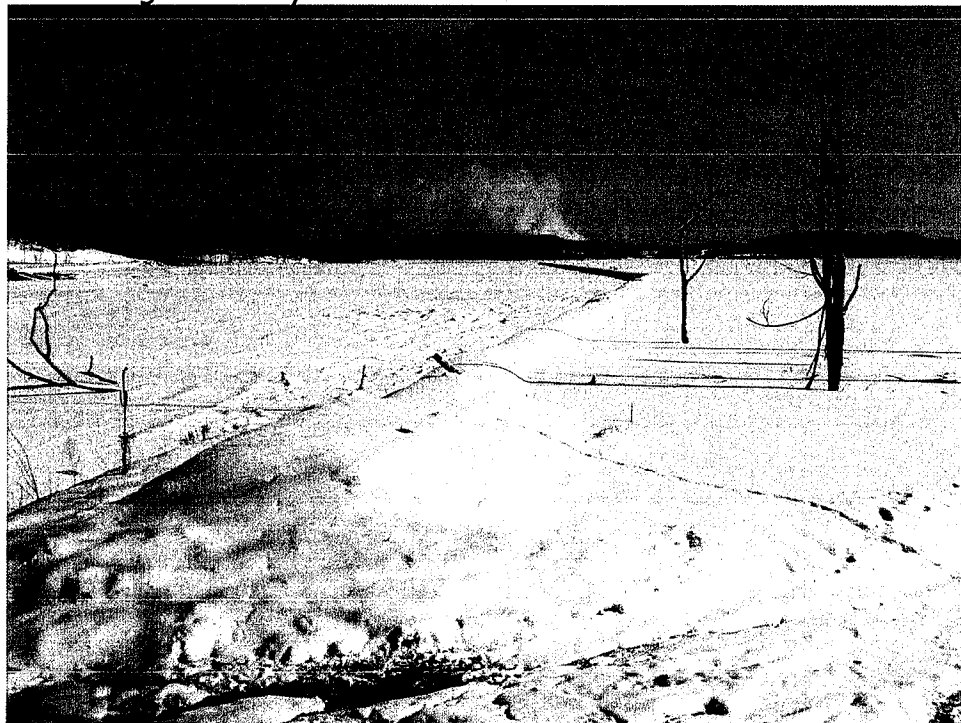
D04-049 01/21/09 Figure 23 View of geotube in West Virginia finger.

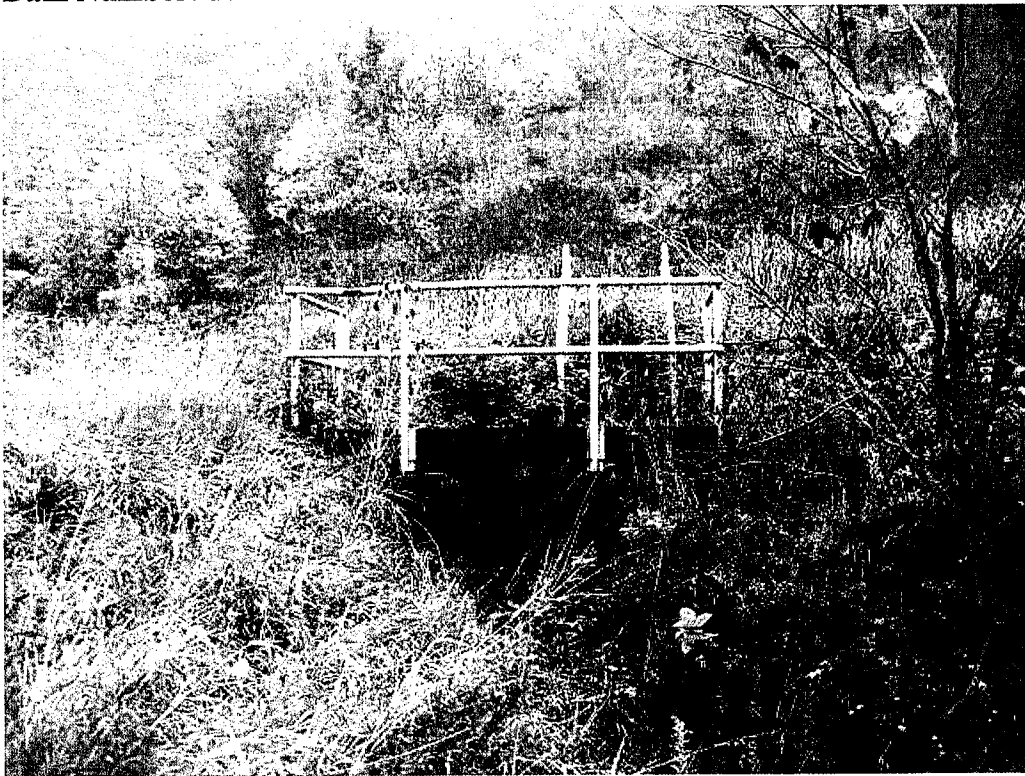
We continue to be concerned with the seepage conditions and stability of the left abutment. These concerns were discussed with you and GAI during the September 13, 2005, meeting held at our office in Harrisburg. As we stated during the meeting, the abutment's steep slope, about 1.8H:1V, the numerous seepage discharges, the embankment plan shows about 20 springs, and the two episodes of slope movements, in December 2001 and August 2004, are our overriding concerns. The best-fit parabolic curve for the total seepage, which is presented as Figure 3 in report number 84, implies a decreasing trend for seepage flows is certainly one good piece of evidence that reduces our concern. We do list the following points that may be at variance with this implication.

d04-049 10/23/07 discharge from left abutment

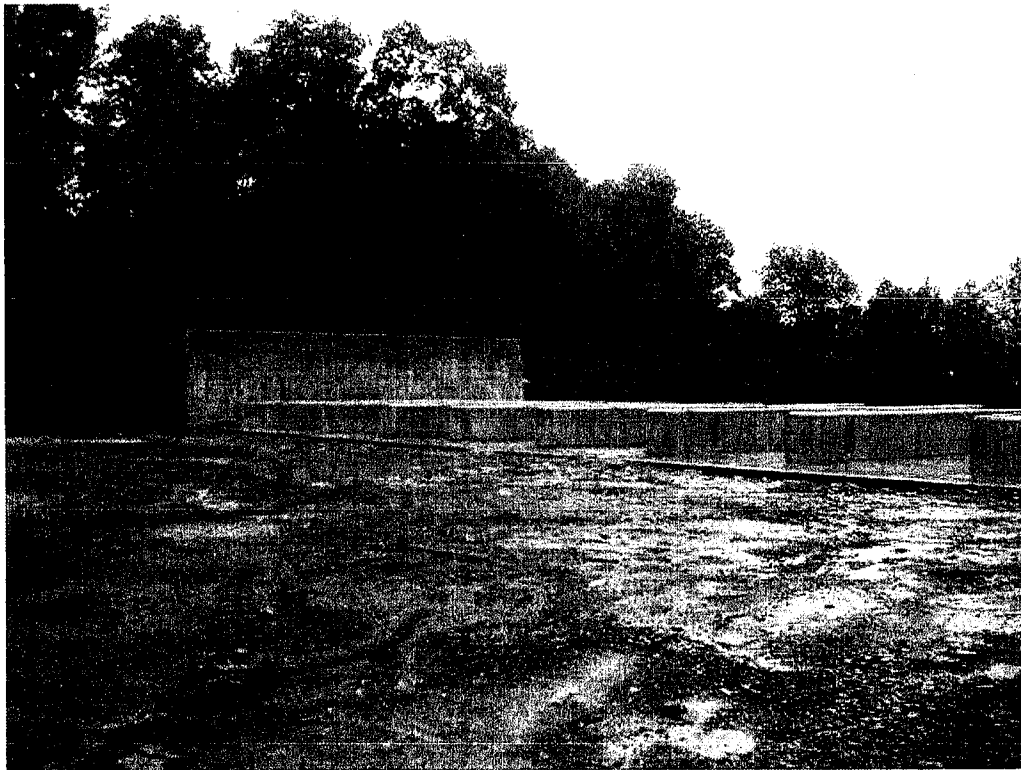
d04-049 10/23/07 US spillway – left side

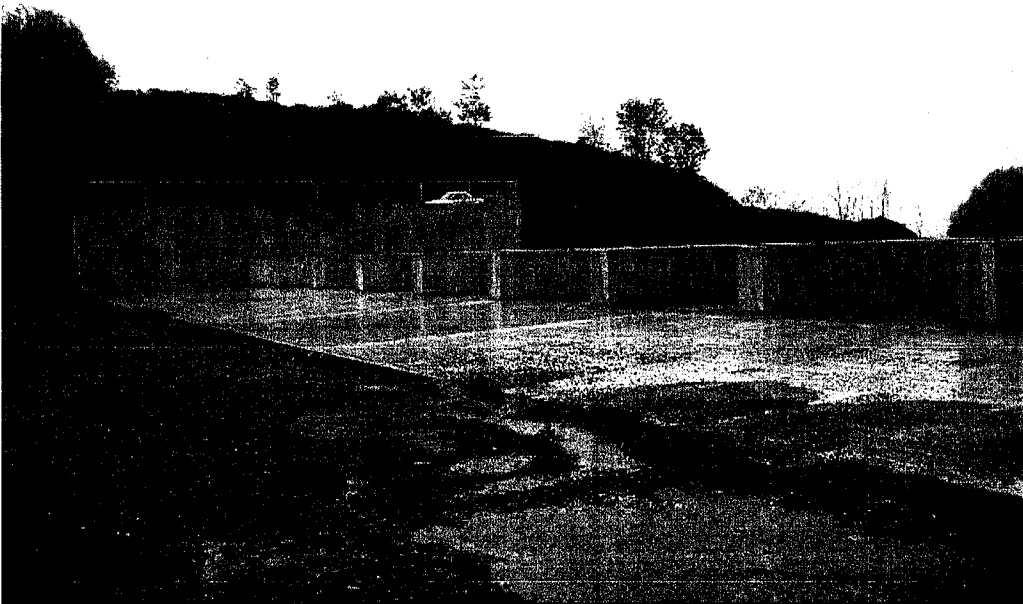
d04-049 10/23/07 DS end of spillway from right

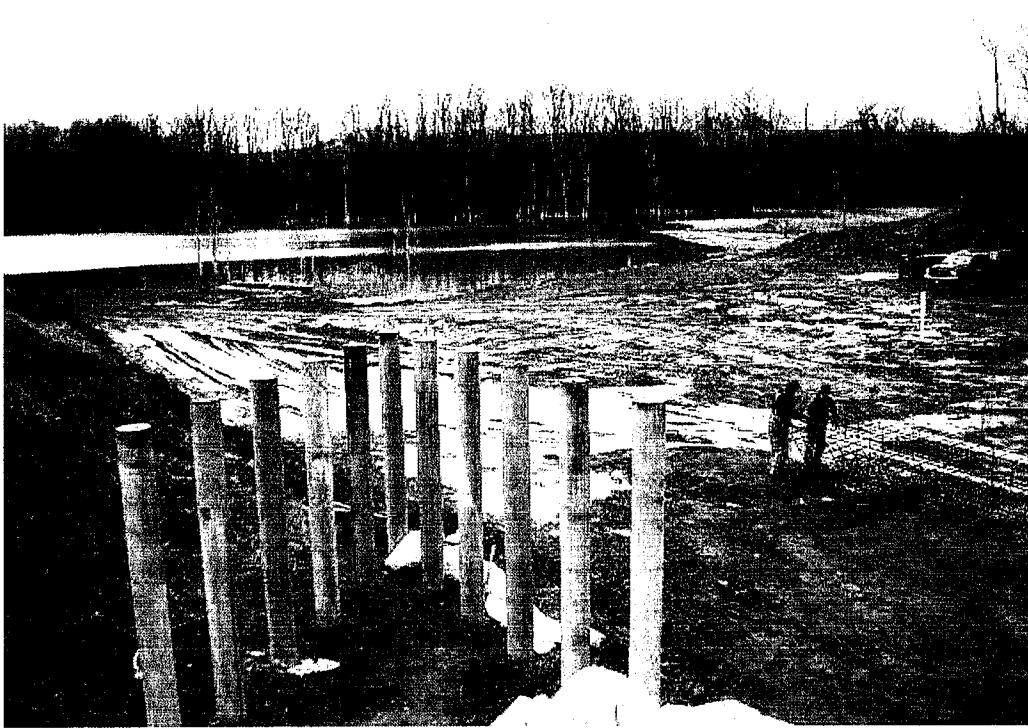
d04-049 11/20/06 spillway approach

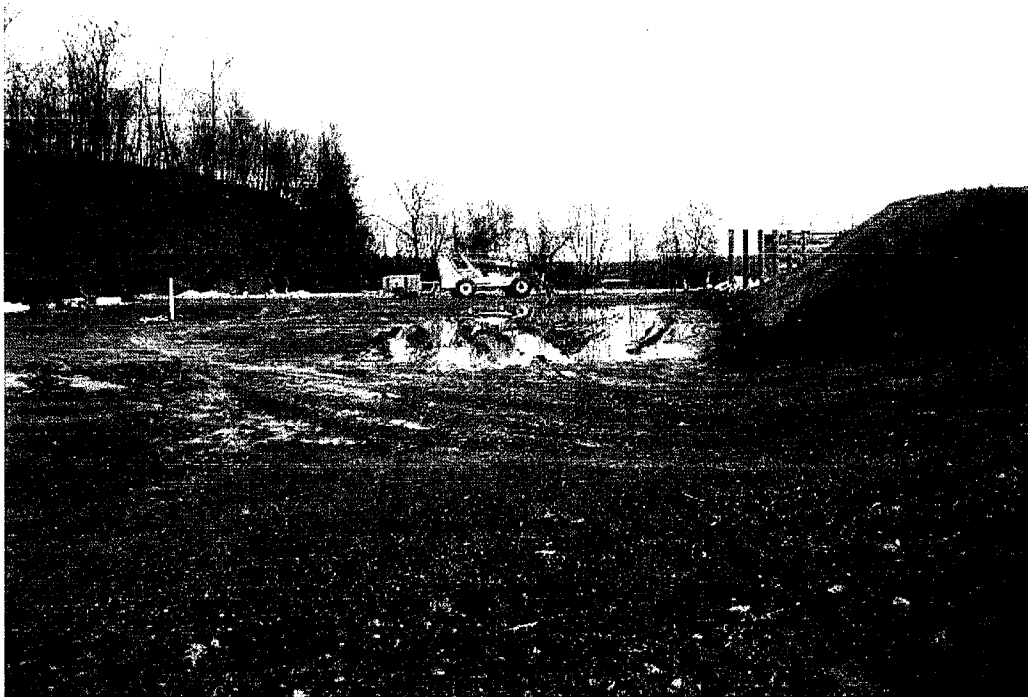
d04-049 11/20/06 spillway from approach

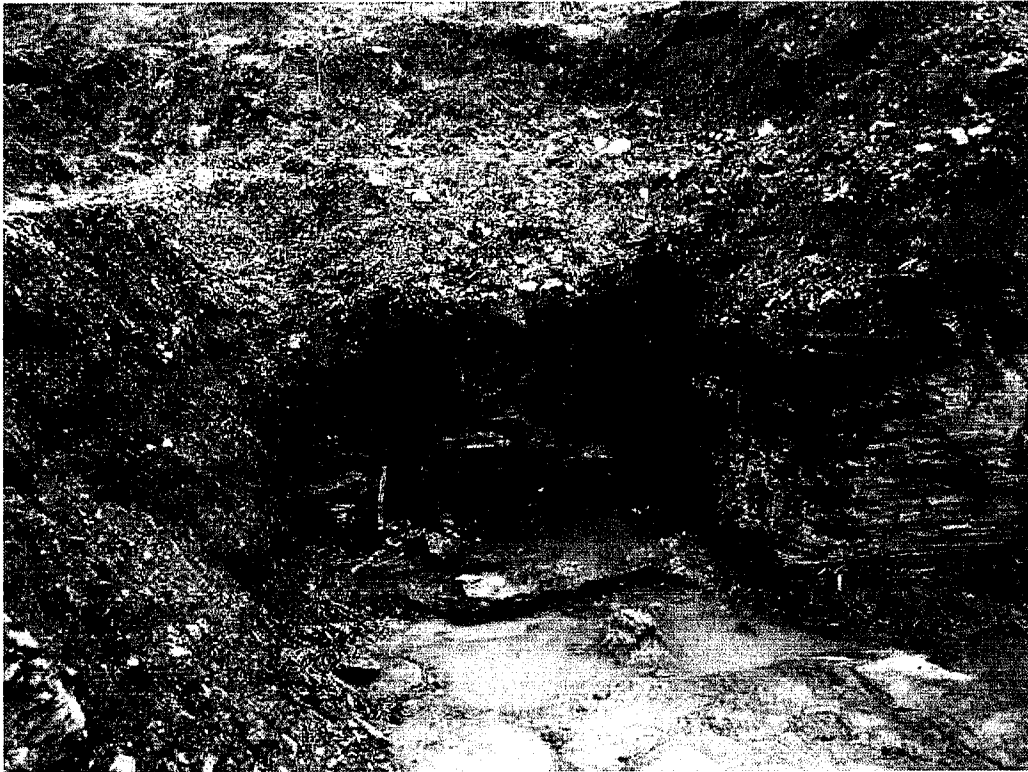
d04-049

DS notch for right spillway wall

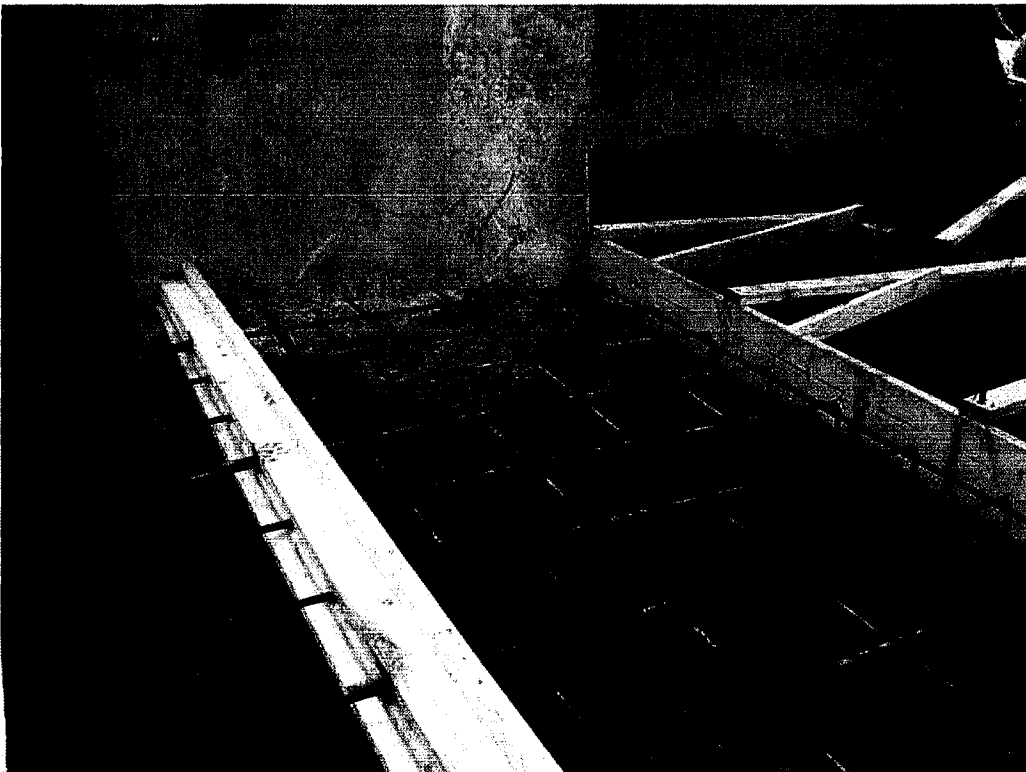
d04-049 11/20/06 forming at right wall

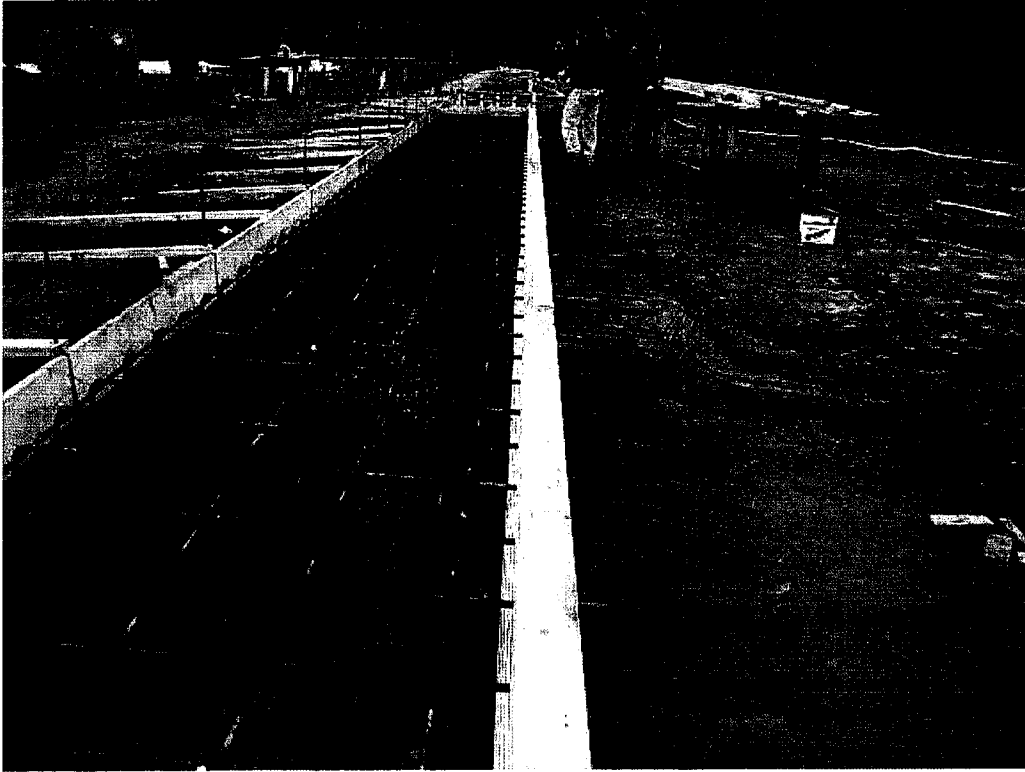
d04-049 11/20/06 forming looking toward left wall

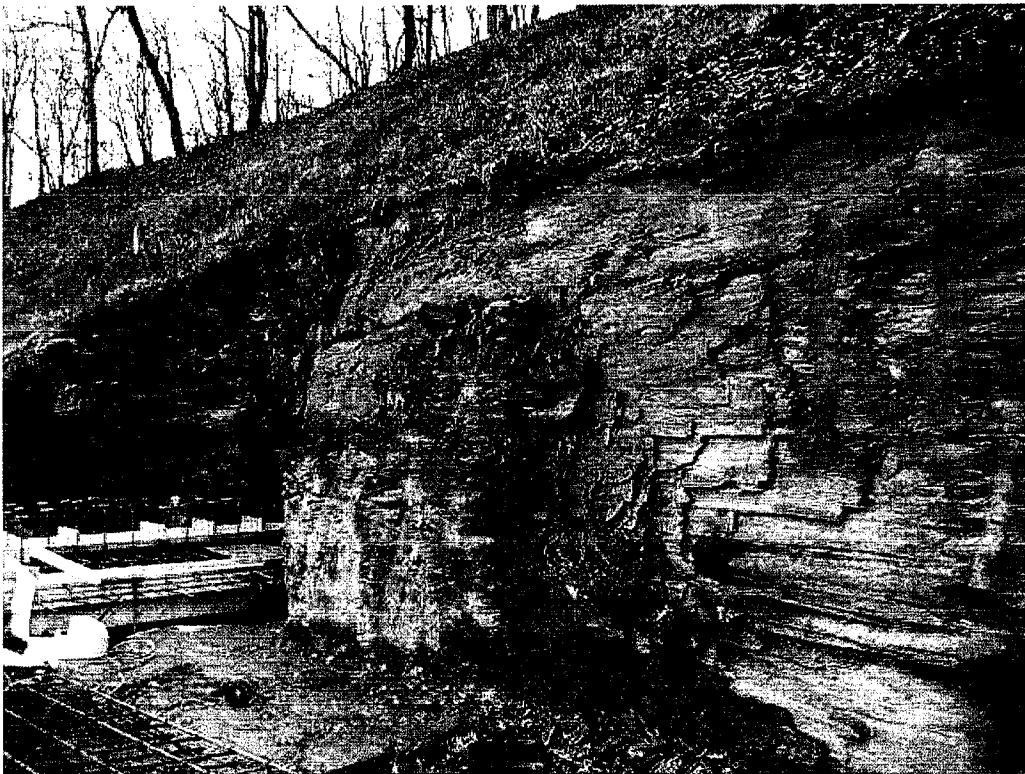
d04-049 11/20/06 left US wall notch

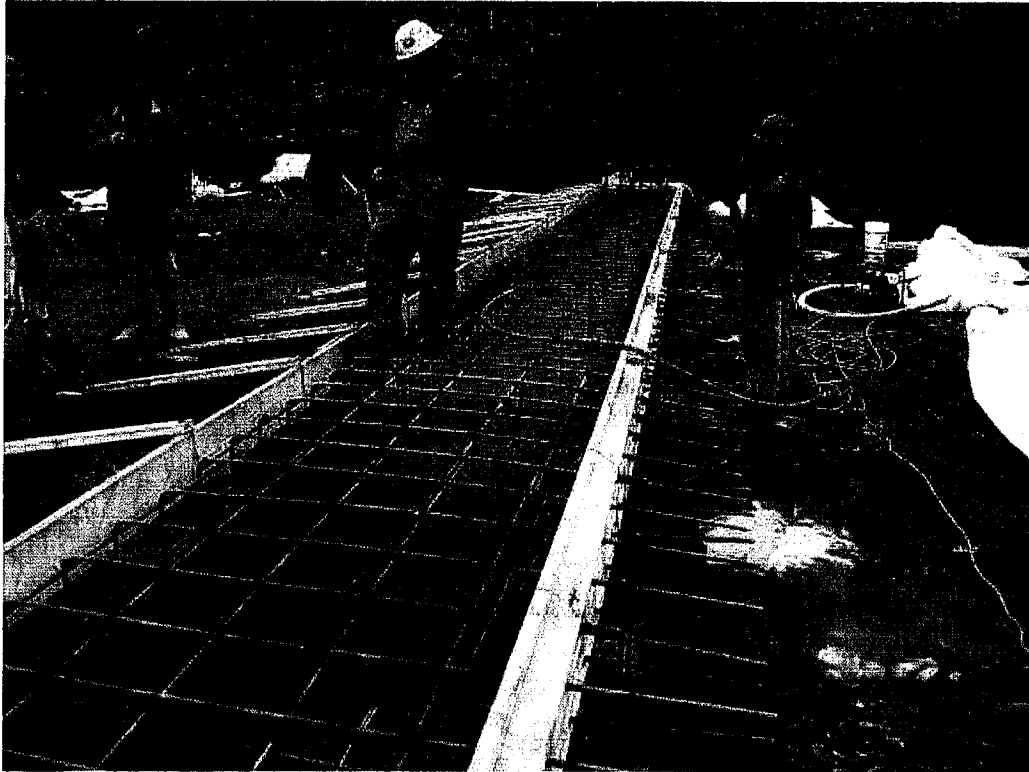
d04-049

the lower ½ of the left side is almost complete

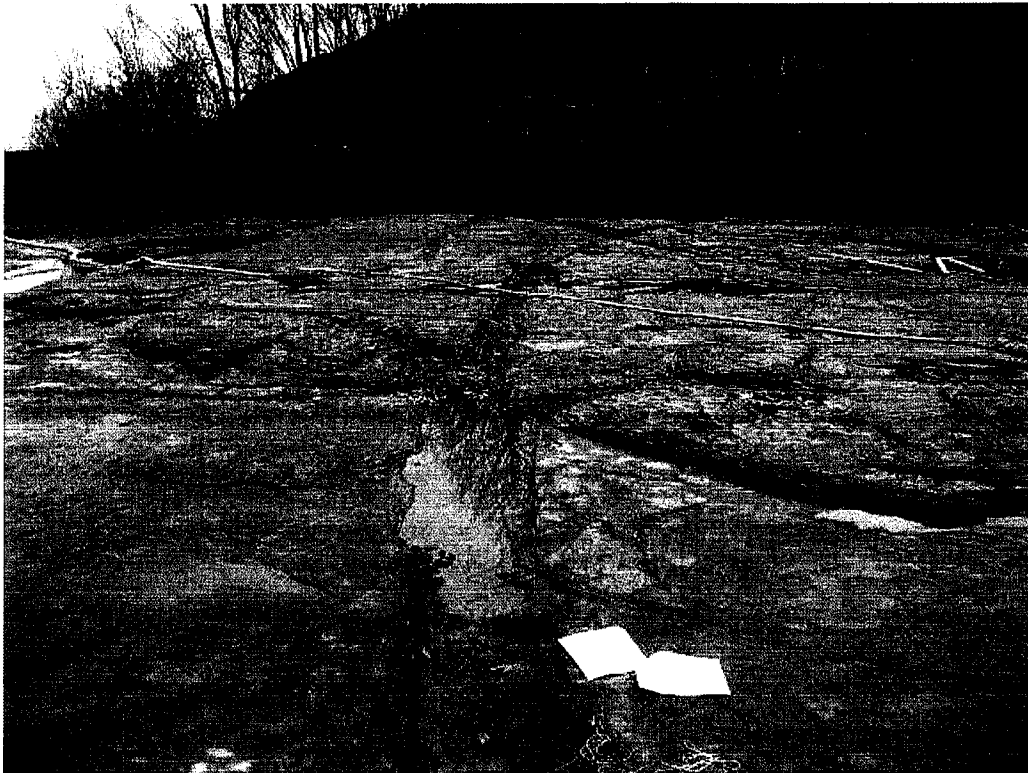
d04-049 11/20/06 rock joint structure looking right – 8.5 x 11 inch paper for scale

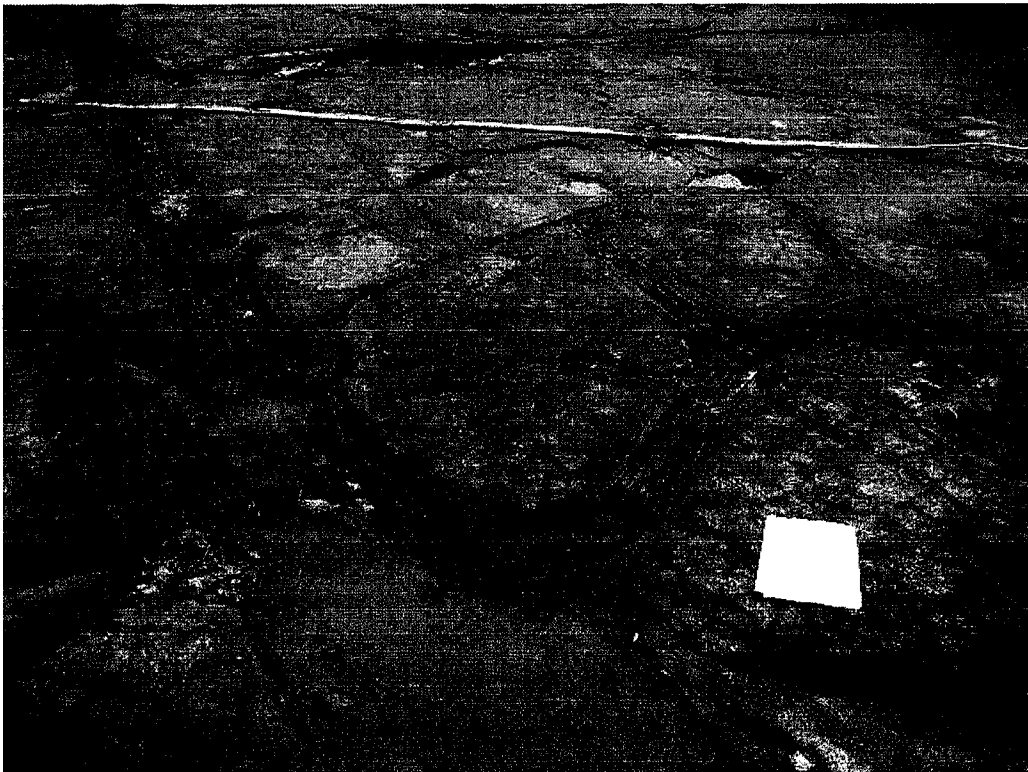
d04-049 11/20/06 rock joint structure looking right – 8.5 x 11 paper for scale

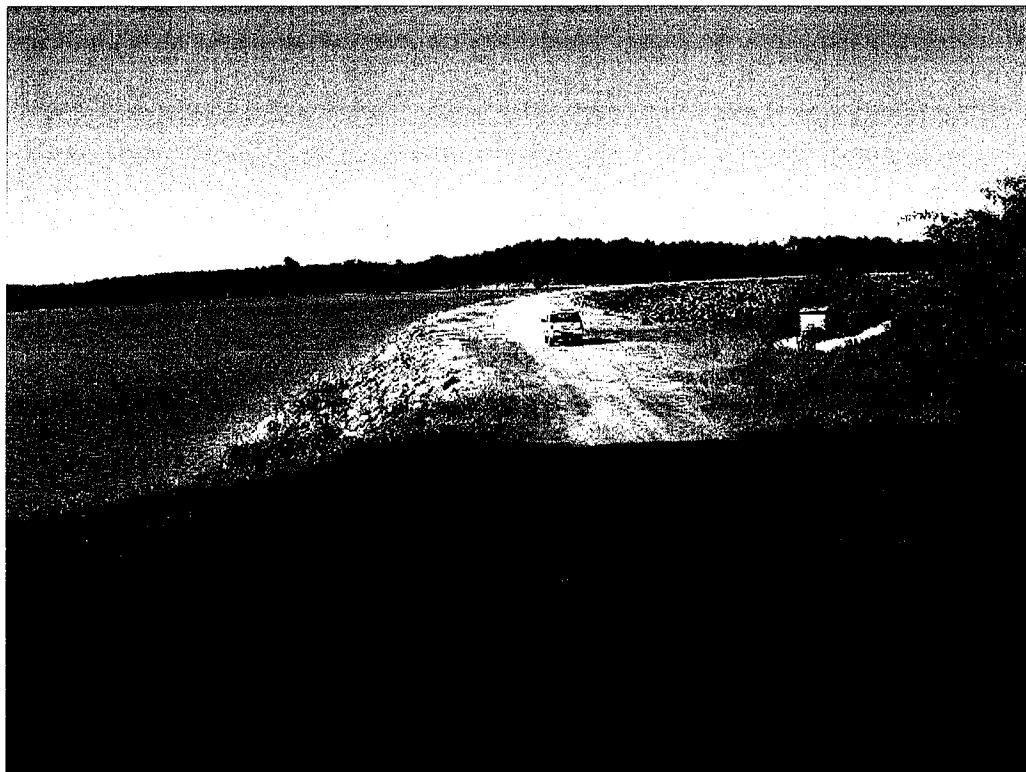
d04-049

US & crest from right

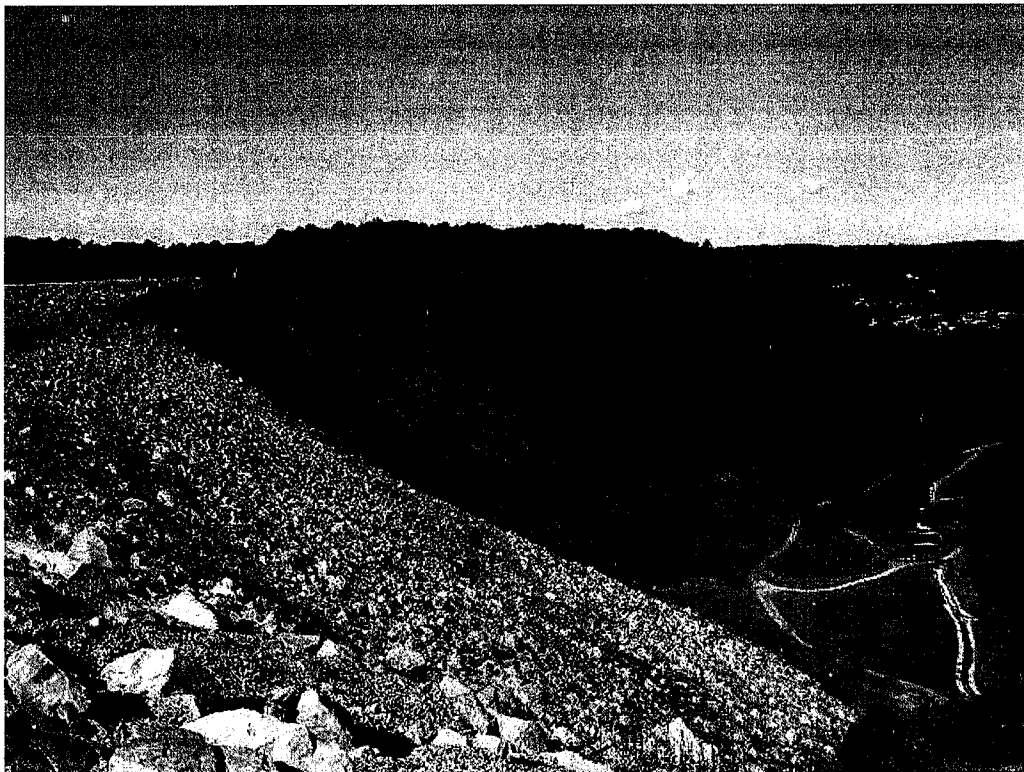
d04-049

DS & left abutment from right crest

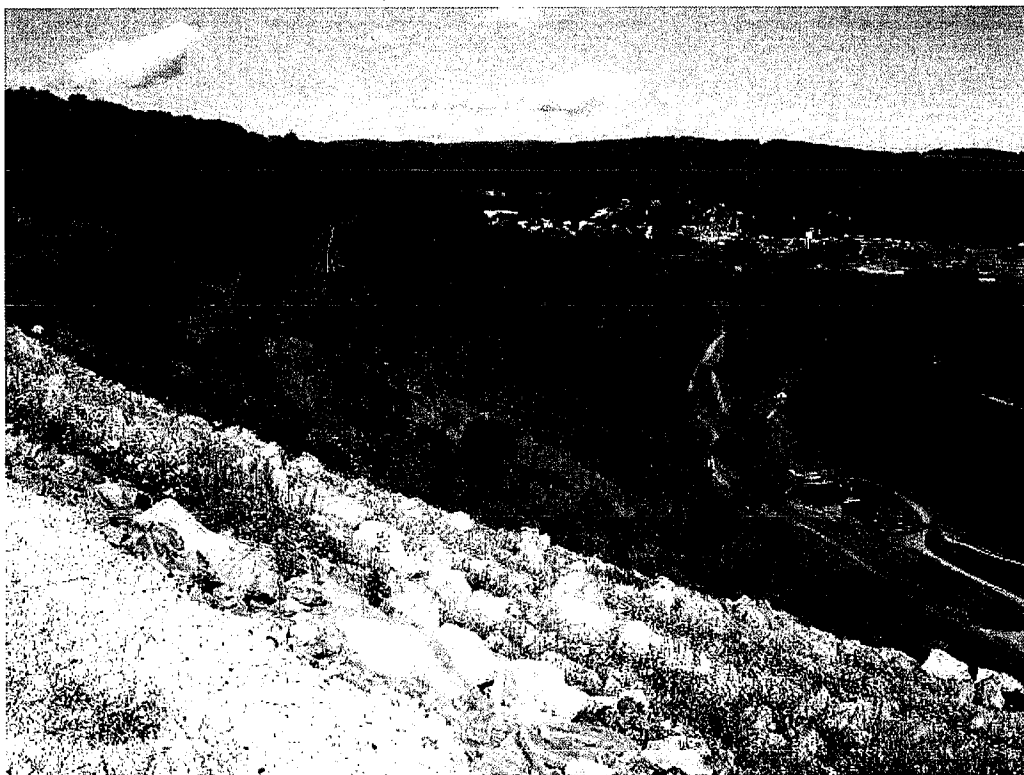
d04-049

left abutment from center crest

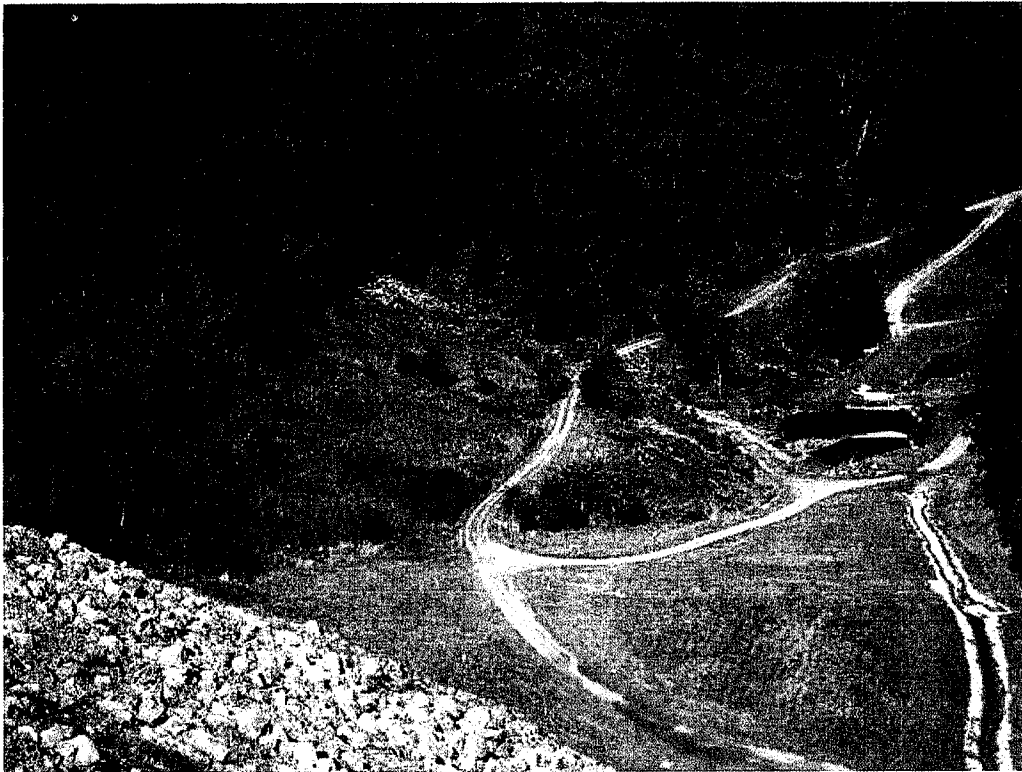
d04-049

toe from center

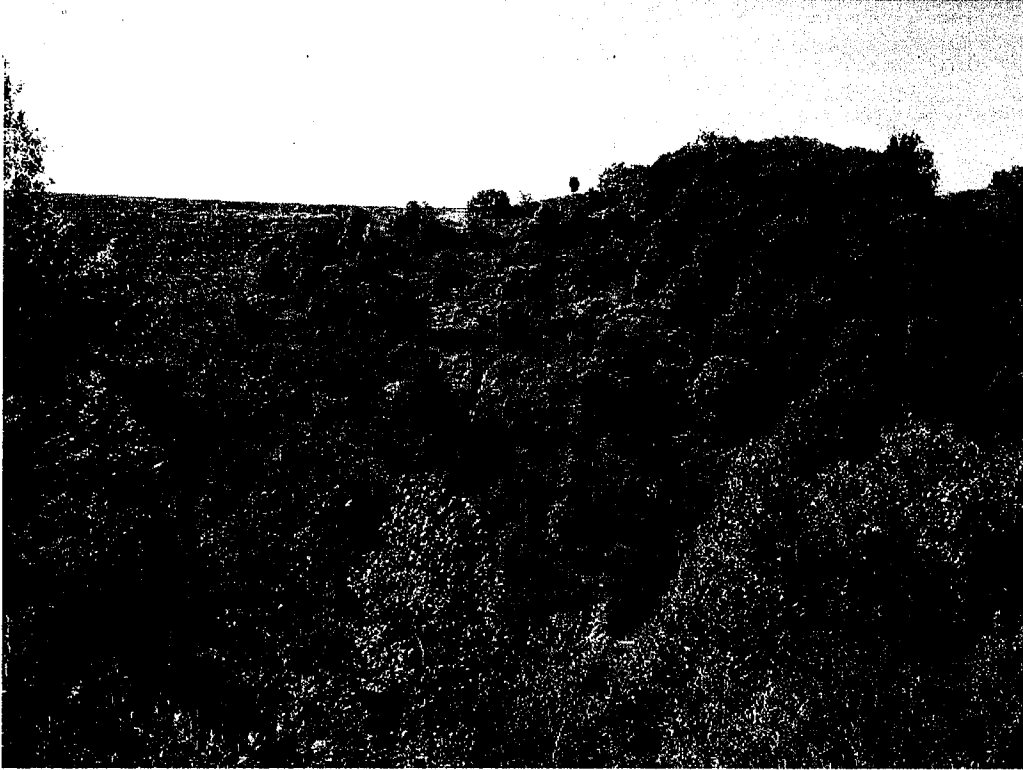
d04-049 9/21/06 left abutment

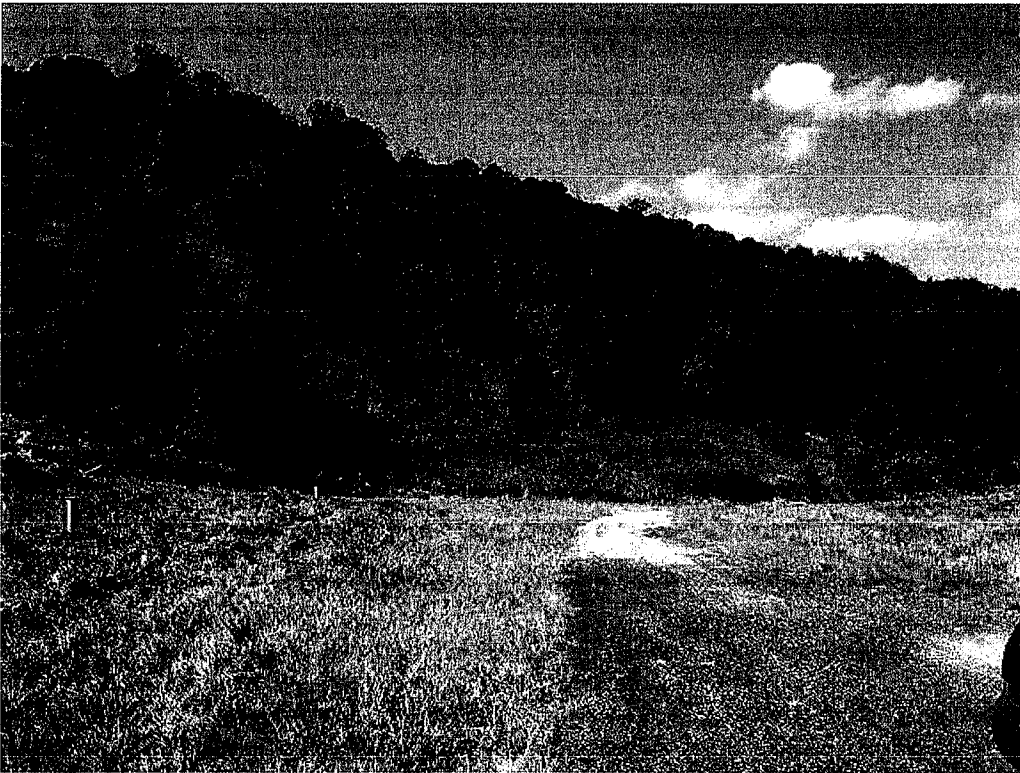
d04-049 9/21/06 left abutment from toe

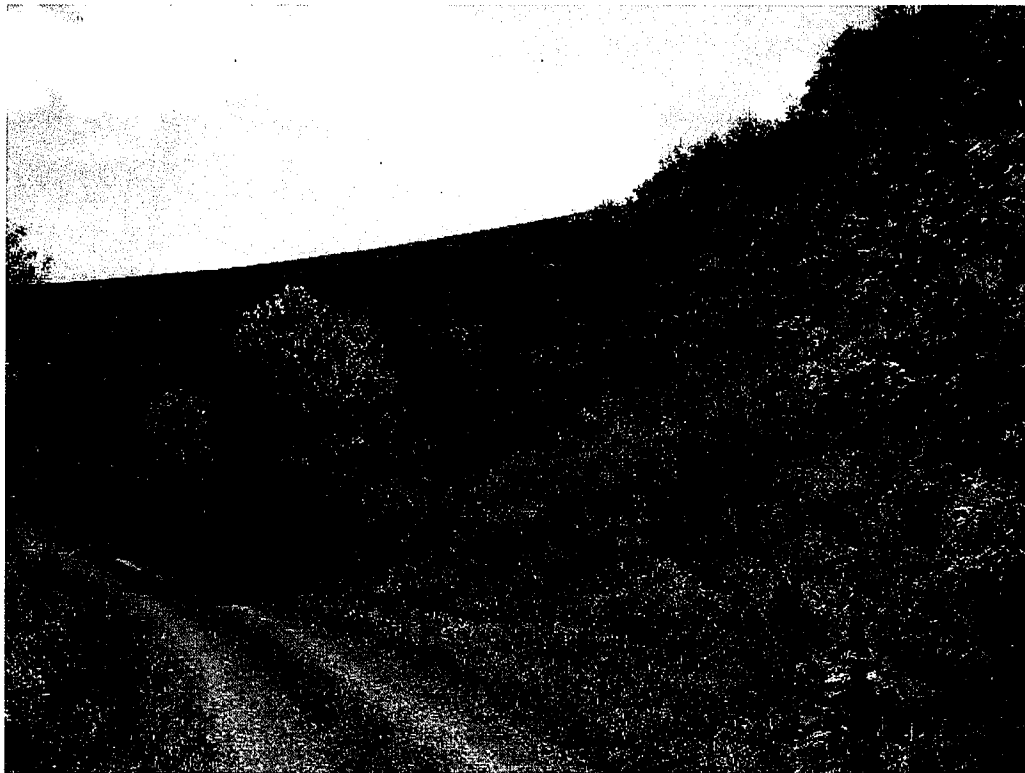
d04-049 9/21/06 lower end of left abutment looking toward dam

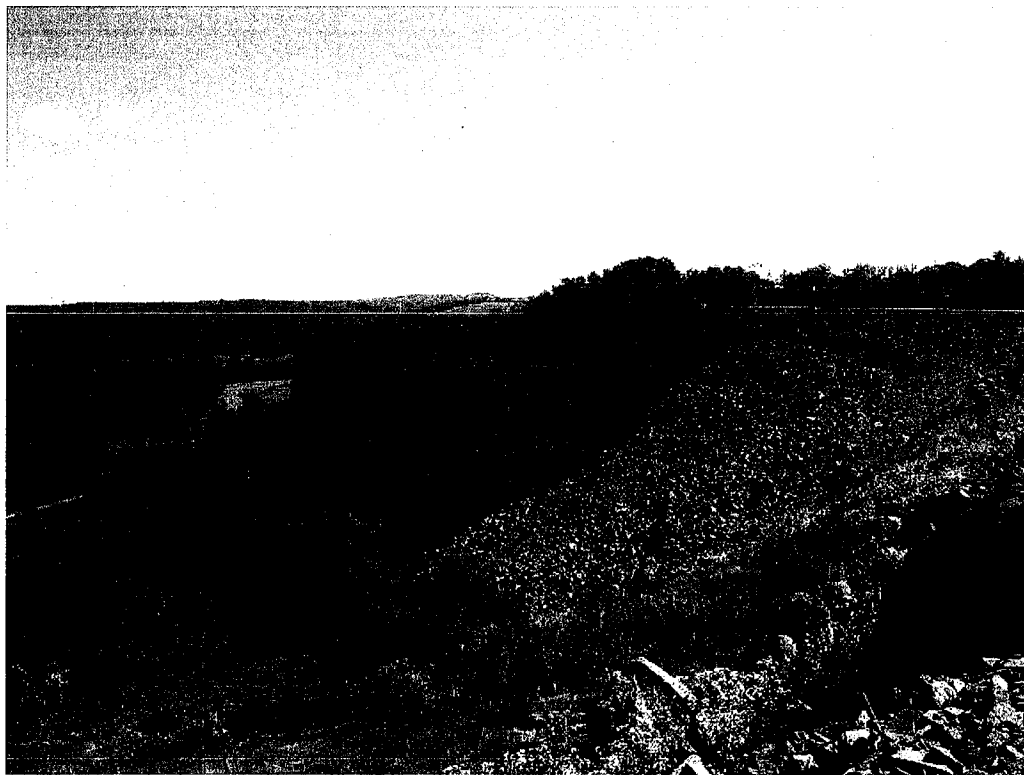
d04-049 9/21/06 DS slope from left

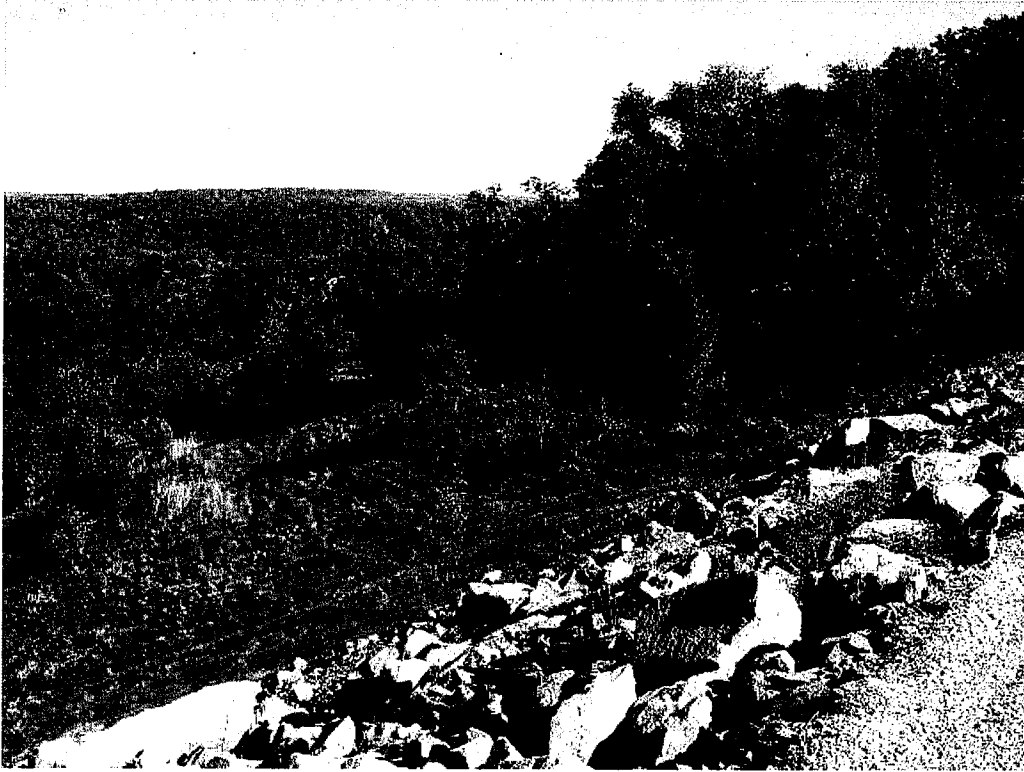
d04-049 9/21/06 right abutment from center

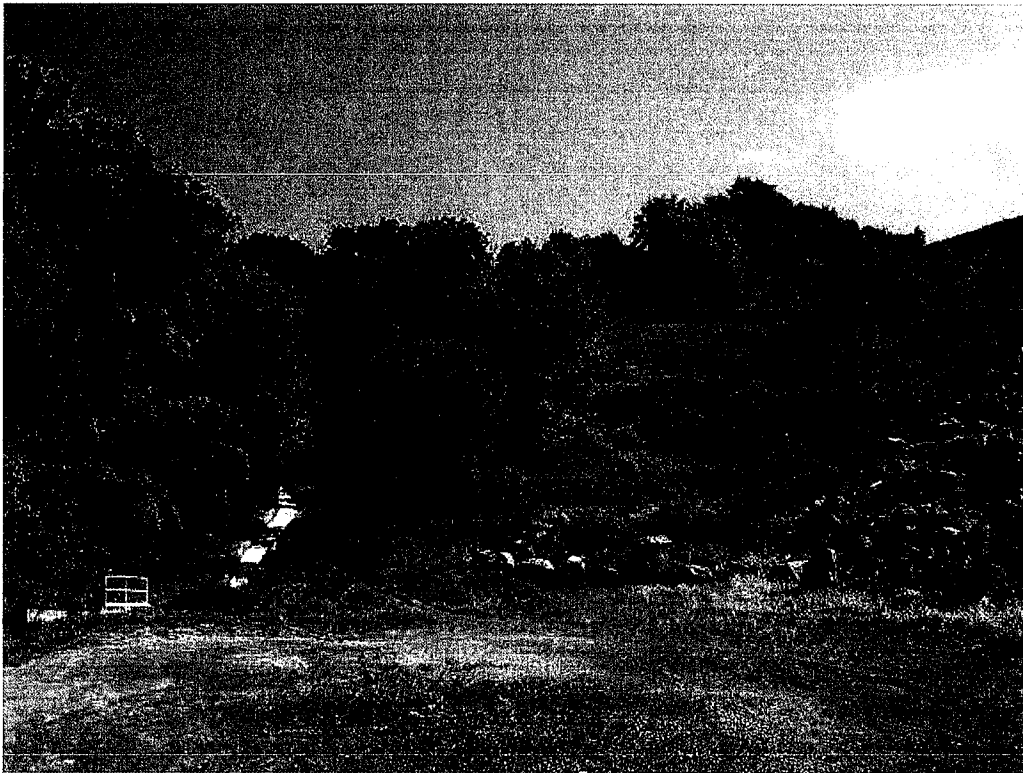
d04-049 9/21/06 right abutment from toe

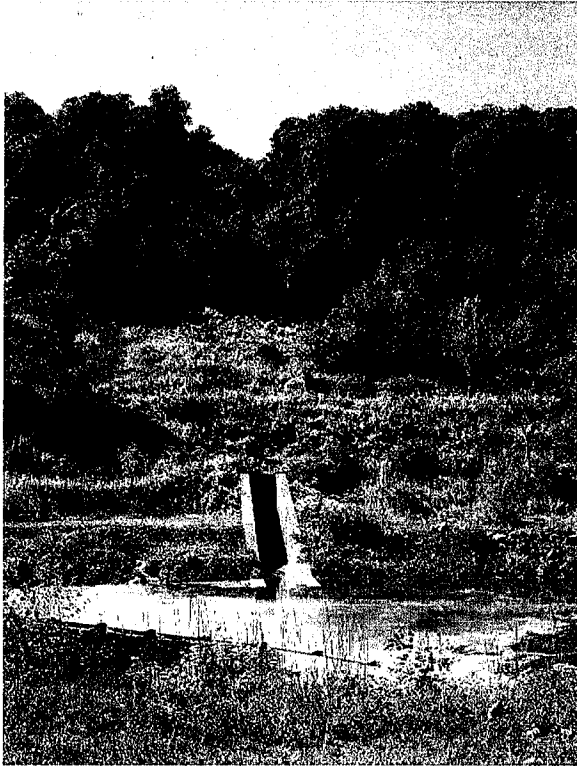
d04-049 9/21/06 outlet of left primary spillway
